MIL2.1-770-6B Reverse Flow

No. 02/2023

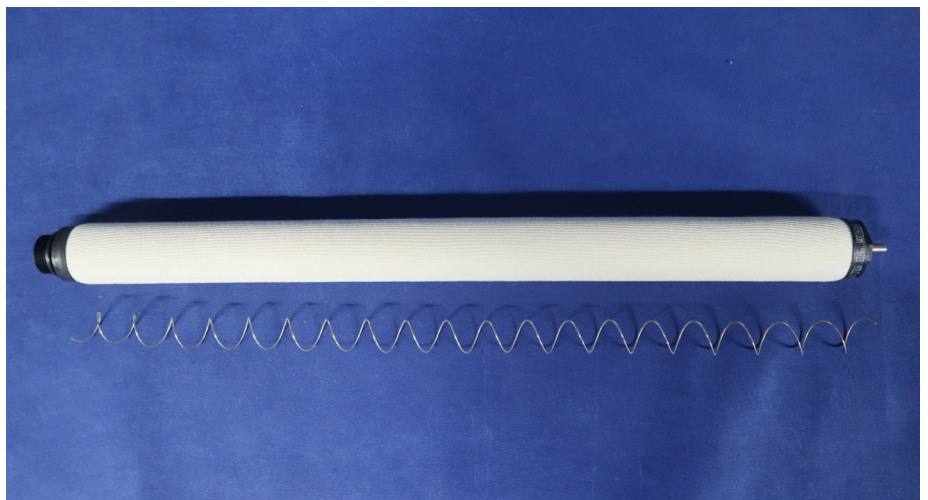
Cases of damage to the internal pleats of the FAUDI Aviation military qualified 2" coalescer model MIL2.1-770-6B were reported. Original cases were confined to refuelling equipment used to fuel Chinook helicopters. We have subsequently had similar reports when fuelling other helicopter types.

While monitoring a fuelling operation it was determined that rate of flow shutdown introduced a transient pressure in the reverse flow direction. Due to the tight pleated filter block inside the 2" diameter coalescer, the result is that the transient surge dislodges the pleated section, causing damage to the pleats.

We introduced a patented solution incorporating an internal wire spiral which prevents the movement of the pleats during limited backflow events. The solution has been tried and tested at locations where damaged pleats had been observed and we determined that the inner spiral overcomes this issues with these unique military operations.

We recommend users check for damage of the inner pleats and where damage is observed, replace the elements with the current manufacture which includes the inner spiral support.
